Technician Turbocharger Guide for the 2003.25 6.0L *Power Stroke* Engine

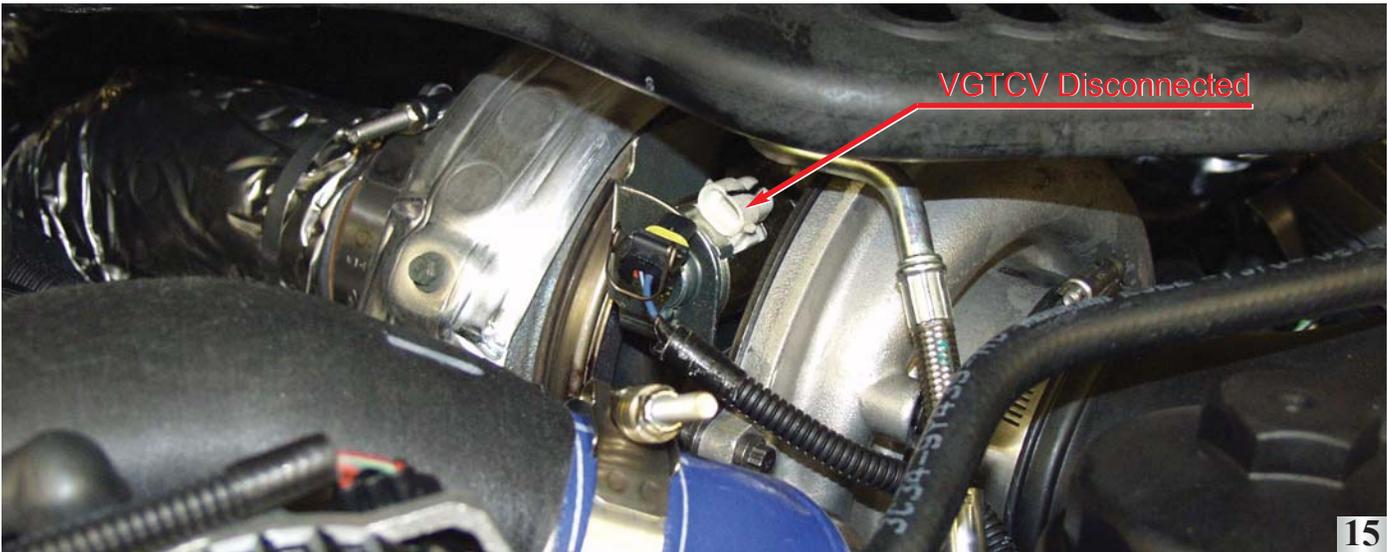
- Raise engine speed to 3500RPM and hold it at that point while monitoring EP and MGP.
- EP should be between 20 and 28 psi and MGP should be between 2 and 6 psi.
- If MGP and EP are both high, disconnect the VGT control valve electrically and rerun the test.
- If MGP and EP change inspect the wiring harness and connections.

- If MGP and EP do not change (lower) when VGTCV is unplugged remove the valve from the turbo, being careful to handle the valve by its solenoid body only, and plug it into the engine harness.

- Then apply pressure to the cam follower (tip of the valve) with your thumb while actuating the valve with the WDS and look for movement. If the valve does not move replace the valve.

- If it does move then remove the snap ring and end cap on the back of the turbocharger vane actuator. **Note: oil will run out of the actuator bore.**

- Use a magnet to push and pull the actuator piston in and out of the bore. If the piston will not move then replace the turbocharger.
- The VGTCV (base part # 6F089) can be tested electrically, measure the resistance of the actuator coil using a DVOM, the resistance should be between 3.42 & 4.18 ohms @ 73°F EOT. If the engine is hot the resistance should be between 4.4 to 5.3 ohms @ 200°F EOT.

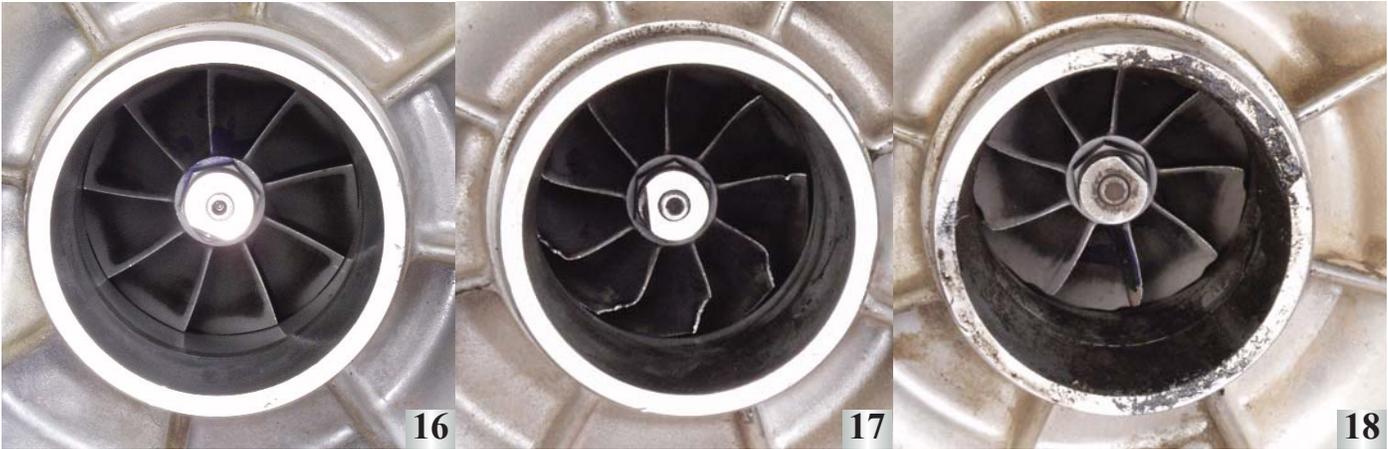
BLADE DAMAGE

Good Turbocharger:

Compressor blades are clean and straight. There are no large gaps between the compressor housing and the compressor wheel. No visible damage to blades. This turbocharger should not be replaced.

Foreign Object Damage: This compressor wheel shows signs of some outside object (nuts, bolts, screws, etc.) coming in contact with the blades while they were spinning.

Dirt Ingestion: Also called dusting. The compressor wheel blades show signs of erosion from dirt entering the intake air system. The blades are rounded off and there is dirt accumulation in the compressor inlet.

Note: For 6.0L Powerstroke diesel engines with engine oil diluted with four or more quarts of oil, the turbocharger endplay needs to be checked (.001" - .004" allowable). Also check radial shaft movement by lifting the shaft up and rotating the shaft to check for compressor or turbine wheel to housing contact. If any wheel contact is noticed, the turbocharger must be replaced.

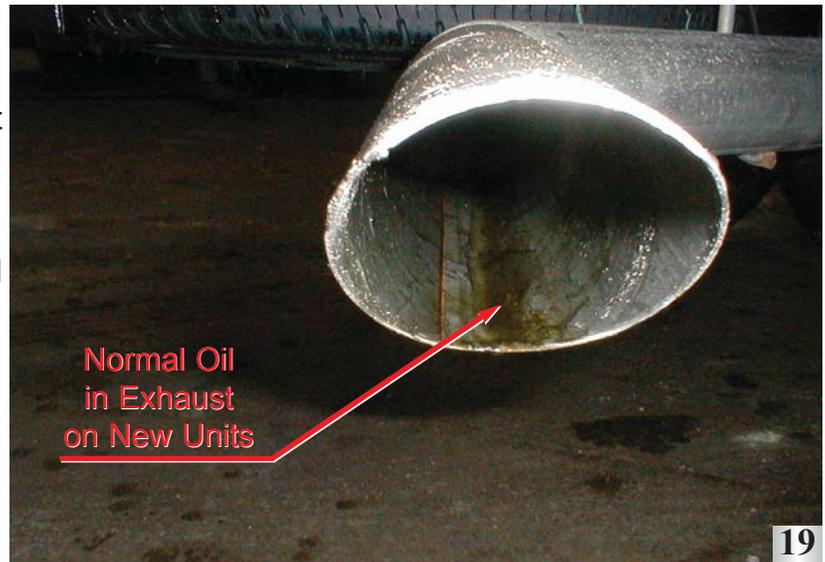
On very low mileage trucks, (typically less than 1000 miles) some turbochargers have been replaced because of an "oily residue" exiting the exhaust pipe. Be aware that during the manufacture of exhaust pipes, lubricants are used in the bending process and to prevent rust. Do not consider replacing the turbocharger just because oil is coming out of the tailpipe. The initial oil in the engine has had dye added, so inspect with a blacklight first. If it is thought that the oil is from the engine, loosen the exhaust pipe from the turbocharger outlet and look for signs of engine oil exiting the turbocharger. If the turbocharger is leaking oil into the exhaust, expect to find the bearings in the unit to be worn and for wheel rub to be present.

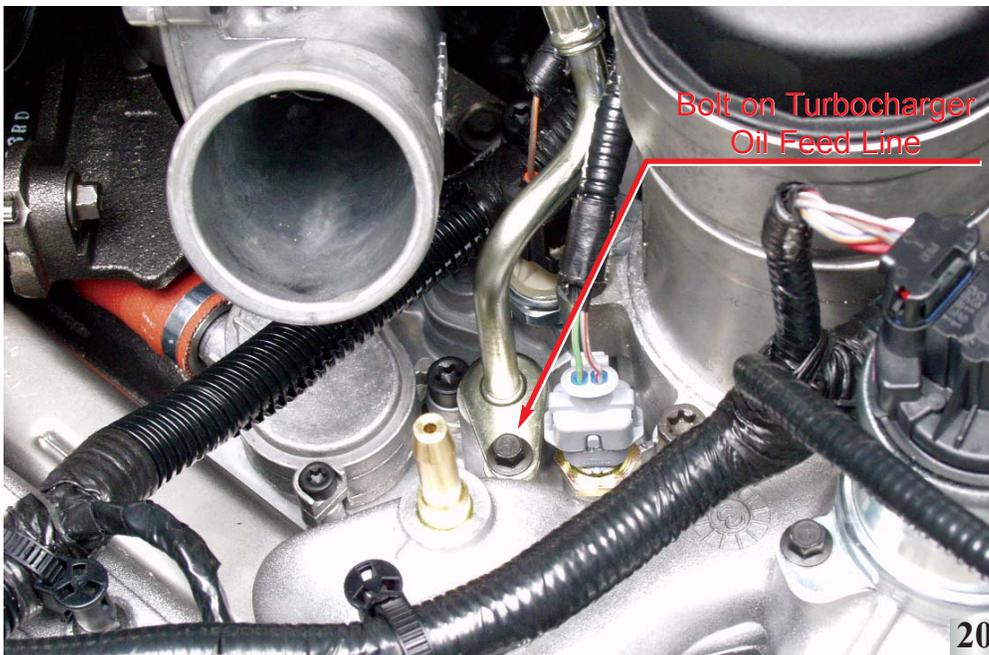
If oil is found leaking off of the back of the engine, one place to look would be the turbocharger since it is mounted in the valley. Some of the possible leak points would be from the oil supply connection, oil drain, center section, and oil seepage from the pipes.

When diagnosing any oil leak it is best to start at the top and most forward point of the affected area. An oil leak that looks like it is coming from the center section may be coming from the oil feed line.

The snap-to-connect turbocharger oil feed line has been replaced with an o-ring sealed, bolt-on line. This was done to reduce leaks due to improper installation.
